**== USS TAYLOR (FFG-50) ==**  
**SEMAT II SHELL CONDITION ASSESSMENT**  
**SURVEY**  
**INTERIOR AREAS**  
**10/29/01 TO 11/09/01**

**PREPARED BY**  
**SUPERVISOR OF SHIPBUILDING CONVERSION**  
**AND**  
**REPAIR**  
**PORTSMOUTH, VIRGINIA**  
**11/10/01**

9 November 2001  
Serial# 1697AY – 118

Q.E.D. Systems, Inc. was tasked by the Supervisor of Shipbuilding Conversion and Repair, USN (SPORT) Portsmouth, VA to conduct an Ultrasonic Thickness (U/T) Survey of specific locations on board USS TAYLOR (FFG-50) during the period of 31 October 2001 – 8 November 2001.

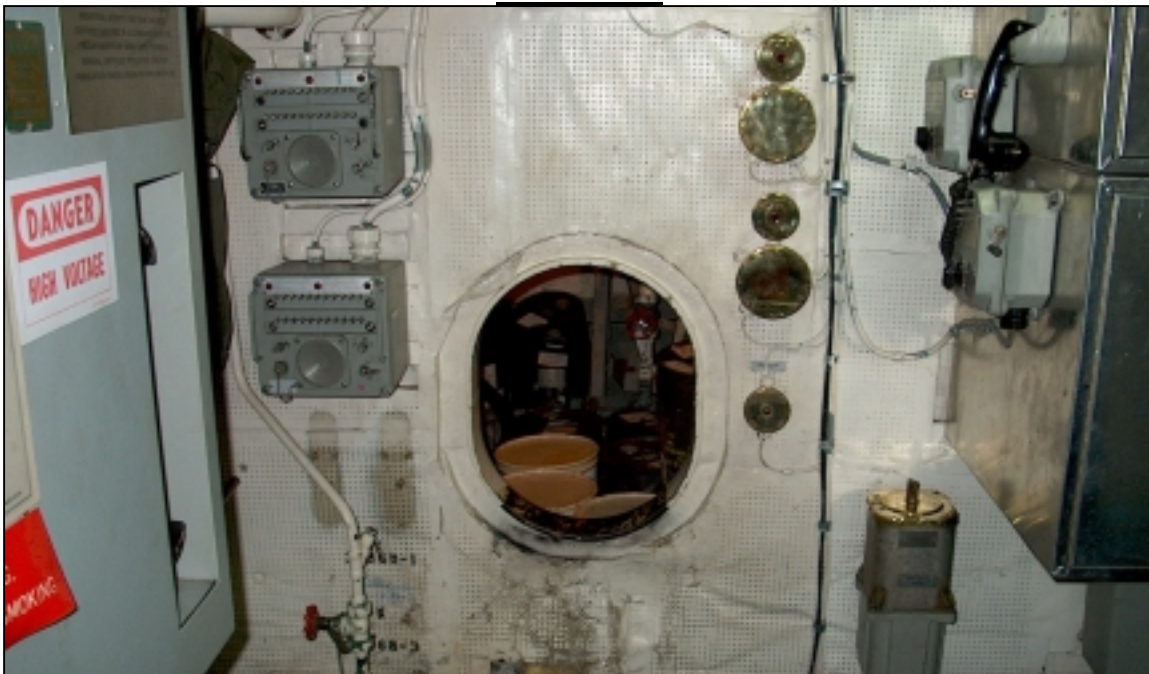
STARBOARD SIDE EDUCTOR SPACE, IN AFTER STEERING

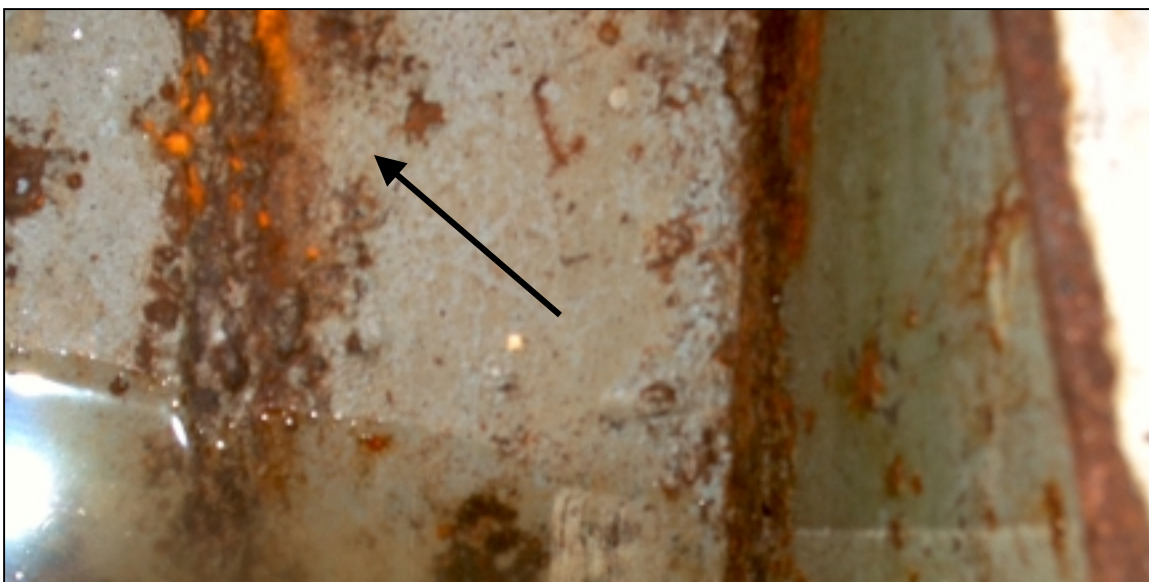
| STBD EDUCATOR APPROXIMATELY 2' AFT OF B HD (368), APPROXIMATELY 20 SF OF LIGHT CORROSION AND PAINT SCALING ON HULL AND STRINGERS | | | | | | | | |

RUST AND SCALING AT TRANSVERSE WELD SEAM APPROX 2 FT AFT OF BHD (368)

| RECOMMEND SHIP'S FORCE CLEAN AREA TO BARE METAL, PRESERVE AND PAINT APPROXIMATELY 20 SF | | | | | | | | |

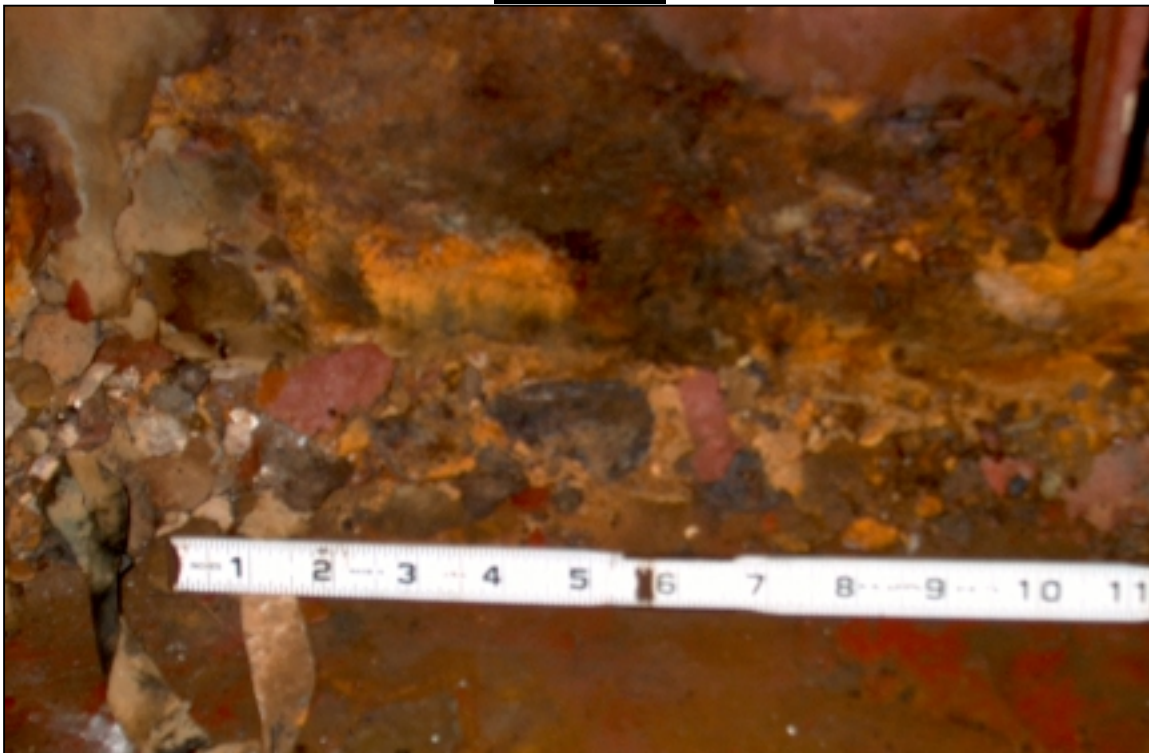
| LOCATION | AREA | RESULTS |
|---|--|---|
| 5-292-0-E AMR 3 | PORT SIDE, BETWEEN BHD (328) AND WF (324) UP TO STRINGER (12) | APPROX 8 SF OF MARGIN PLATE IS THINNING BELOW THE 25% WASTAGE CRITERIA. APPROX 60 SF FROM MARGIN PLATE TO STRINGER (12) HAS HEAVY CORROSION AND PAINT SEPARATION. |

PORT SIDE, BETWEEN WF (324) AND BHD (328) HEAVY CORROSION ON MARGIN PLATE  
AND SHELL SEE DRAWING FOR U/T READING

| RECOMMENDED REPAIRS: RECOMMEND REPAIR ACTIVITY, CLEAN AND GAS FREE POTABLE WATER TANK (5-308-2-W). CUT OUT | | | | | | | | |
| APPROXIMATELY 8 SF OF MARGIN PLATE, REPLACE WITH .250 MILD STEEL, LEAK TEST TANK. CLEAN APPROX 60 SF OF AREA BETWEEN | | | | | | | | |
| BHD (328) AND WF (316) TO BARE METAL, PRESERVE AND PAINT. REPAIRS TO BE ACCOMPLISHED DURING | | | | | | | | |

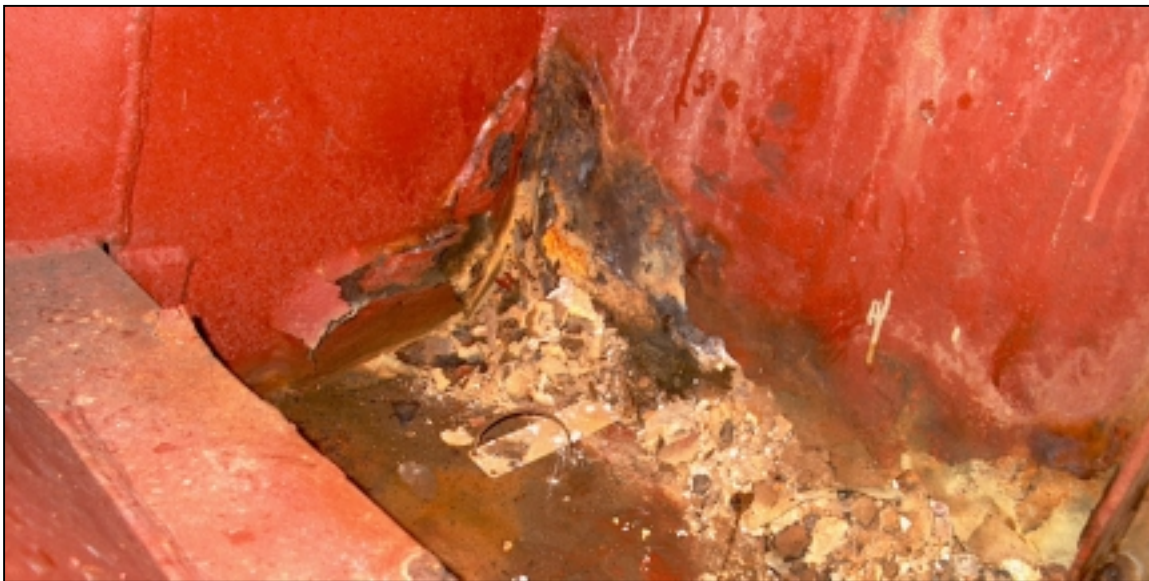
HEAVY CORROSION ON MARGIN PLATE WHERE IT MEETS WF (324) AND SHELL  
LOW U/T READINGS WERE REVEALED IN THIS AREA.

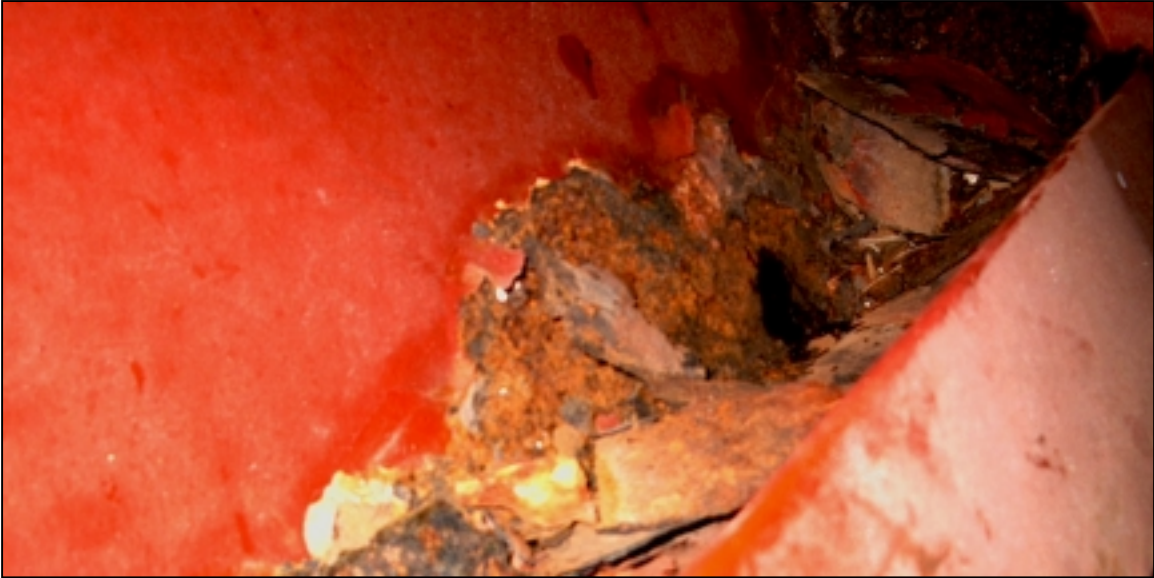
PORT SIDE, AFT OF WF (324) WERE STRINGER (9) MEETS THE SHELL PLATE

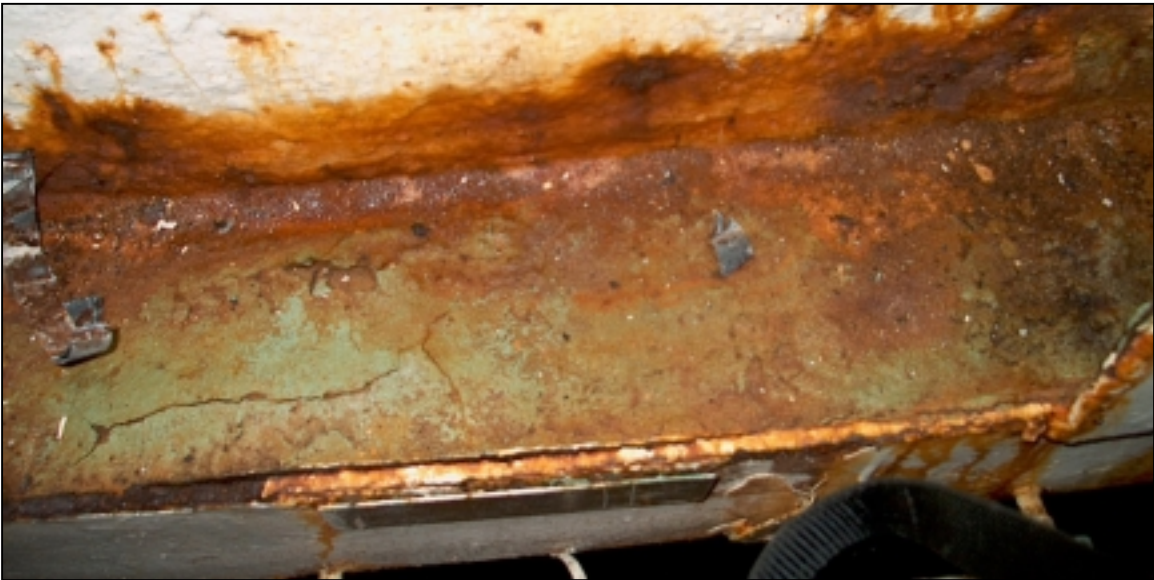
STRINGER (11) FWD OF WF (224)

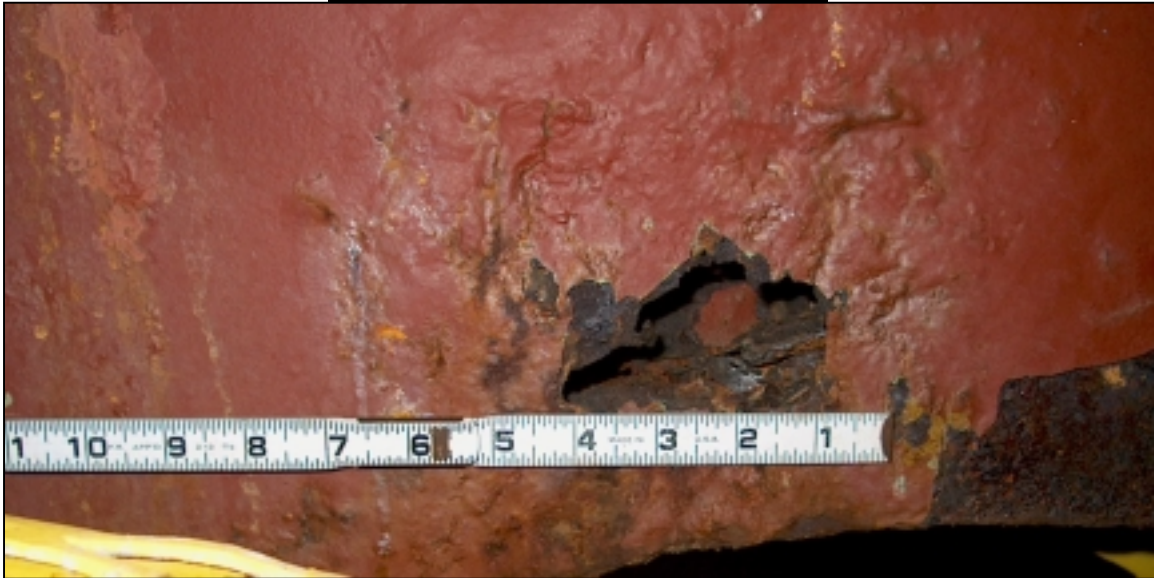
| LOCATION | AREA | RESULTS |
|---|--|---|
| 5-292-0-E AMR 3 | CENTER LINE, TRANSVERSE WEB FRAME 316 | TRANSVERSE WEB FRAME IS HOLED ABOVE THE SHAFT. APPROX 16 LF OF ANGLE STIFFNERS IS DETERIORATED ON FWD SIDE OF TRANSVERSE WEB FRAME. |

| IS HOLED ABOVE SHAFT. 4 X 4 ANGLE STIFFENERS ON FWD SIDE OF TRANSVERSE WEB FRAME ARE DETERIORATED. | | | | | | | | | | | |

LARGE HOLE IN TRANSVERSE WEB FRAME (316) LOOKING FWD

| RECOMMENDED REPAIRS: RECOMMEND REPAIR ACTIVITY, CUT OUT AND REPLACE APPROX 8 SF OF TRANSVERSE WEB FRAME (316), REPLACE WITH .250 MILD STEEL. CUT OUT AND REPLACE APPROX 16 LF OF 4X4X.375 ANGLE. CLEAN ENTIRE AREA AND PAINT TO MATCH. WORK MUST BE ACCOMPLISHED DURING DRYDOCK AVAILABILITY. | | | | | | | | | | | |

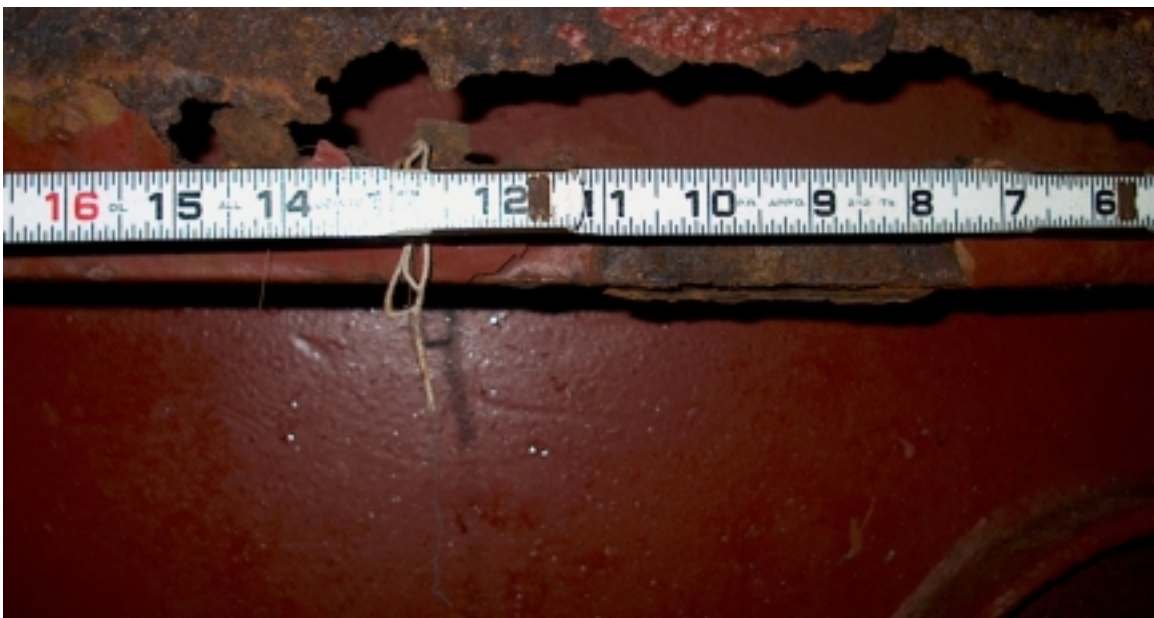
TRANSVERSE WEB FRAME (316) LOOKING AFT, CORRODED STIFFENER.

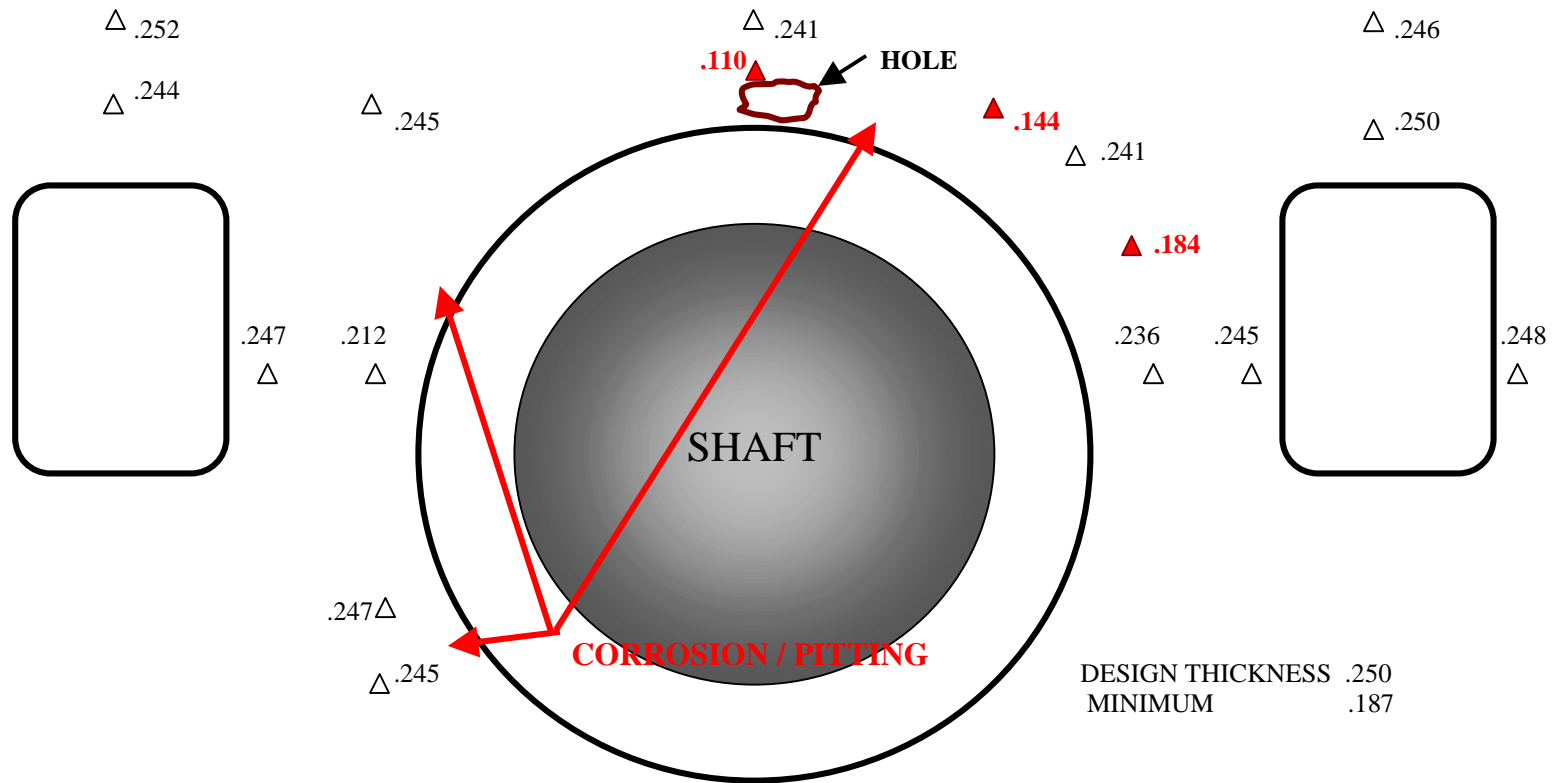
USS TAYLOR (FFG-50)  
AUXILIARY MACHINERY ROOM 3. (5-292-0-E)  
TRANSVERSE WEB FRAME (316)

TRANSVERSE WEB FRAME 316  
LOOKING FORWARD

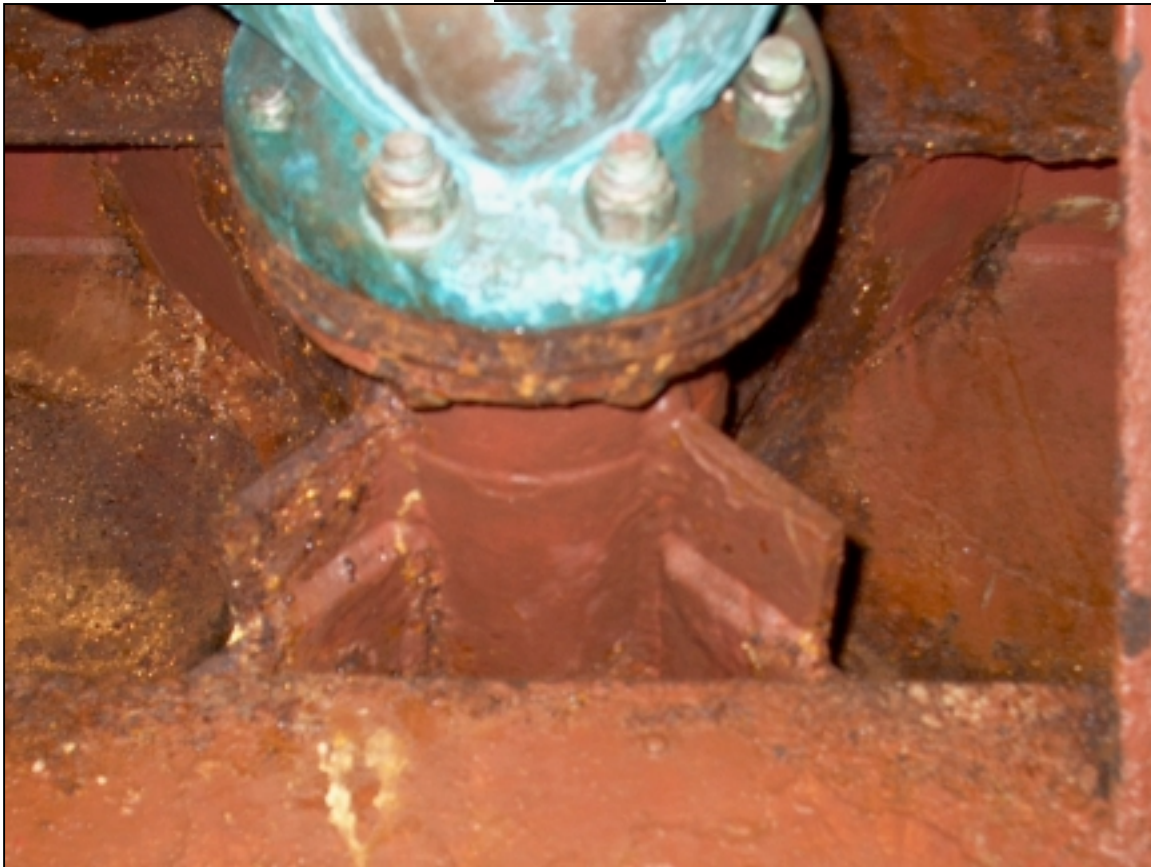
| BETWEEN WF (264-270) FROM MARGIN PLATE TO STRINGER (13), APPROX 80 SF OF SURFACE RUST AND HEAVY PAINT SEPARATION. U/T READINGS ARE SATISFACTORY, SEE DRAWING. | | | | | | | | |

SALT WATER OVERBOARD DISCHARGE BETWEEN WEB FRAMES (264 -270)  
HEAVY PAINT SEPARATION AND SURFACE RUST, U/T READINGS WERE SATISFACTORY  
SEE DRAWING

| RECOMMEND SHIPS FORCE CLEAN ENTIRE AREA TO BARE METAL, PRESERVE AND PAINT TO MATCH APPROX 80 SF | | | | | | | | |

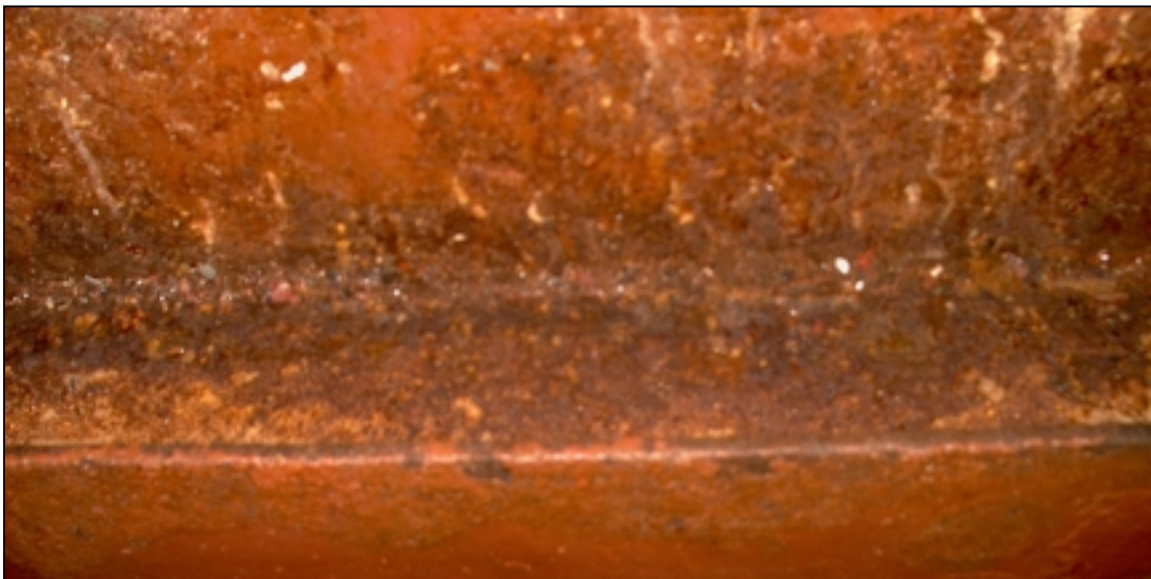
STRINGER (9) TOP VIEW

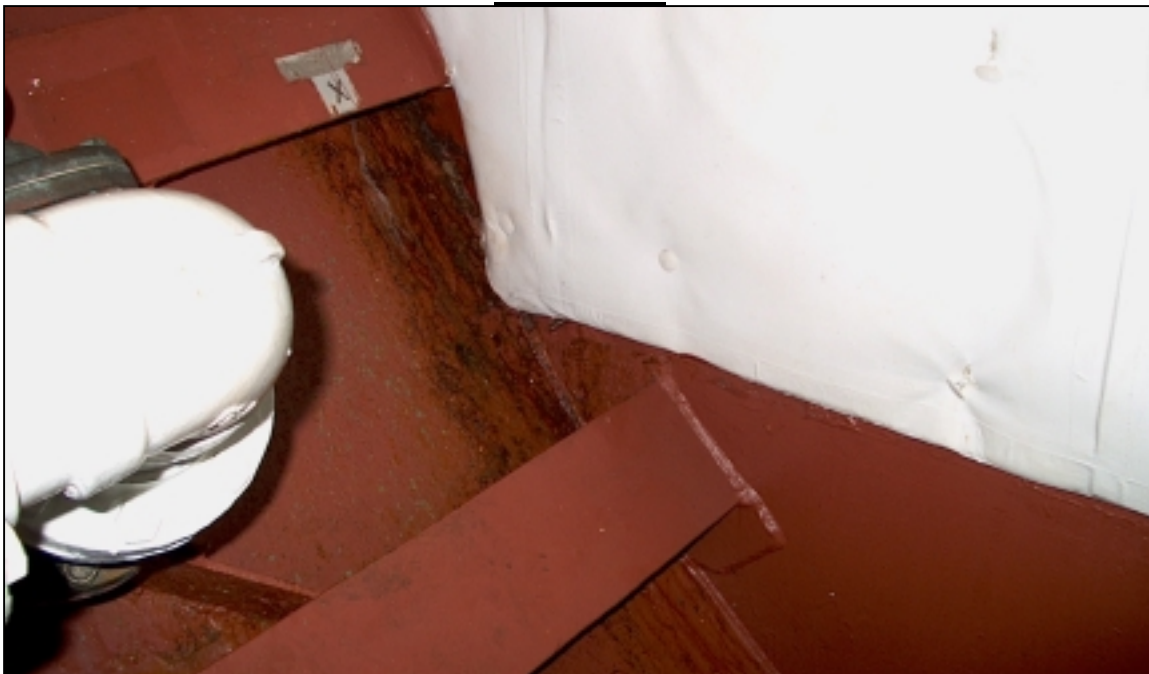
| CORROSION ON SHELL PLATE AND BHD (212), FROM THE ESCAPE TRUNK TO THE U/L GRATING. U/T READINGS WERE SATISFACTORY, SEE DRAWING. | | | | | | | | |

PORT SIDE, CORROSION ON SHELL AT BHD (212)

| RECOMMEND SHIPS FORCE REMOVE LAGGING ON BHD (212) UP TO THE U/L GRATING, | | | | | | | | |
| LAGGING REMOVAL ON BHD (212) APPROX 100 SF TOTAL, PRESERVE AND PAINT. RECOMMEND NOT REPLACING LAGGING | | | | | | | | |

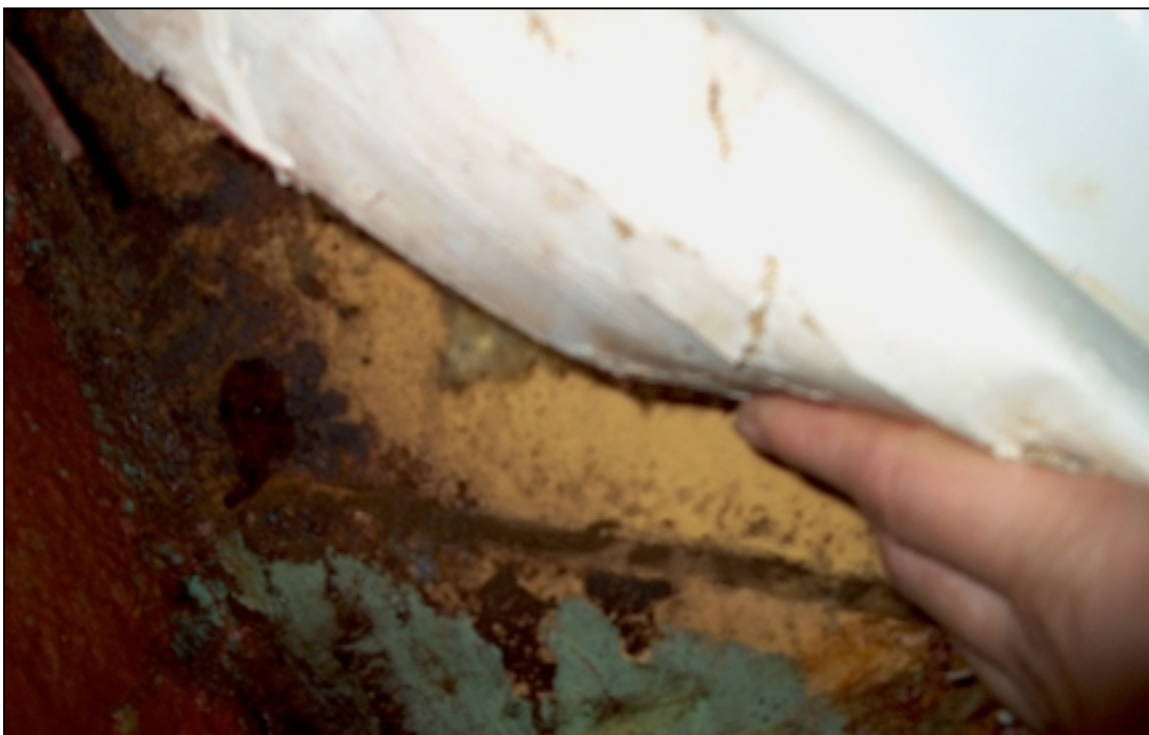
CORROSION ON BHD (212) WHERE IT MEETS SHELL PLATE U/T READINGS WERE SATISFACTORY. REMOVAL OF INSULATION IS RECOMMENDED.

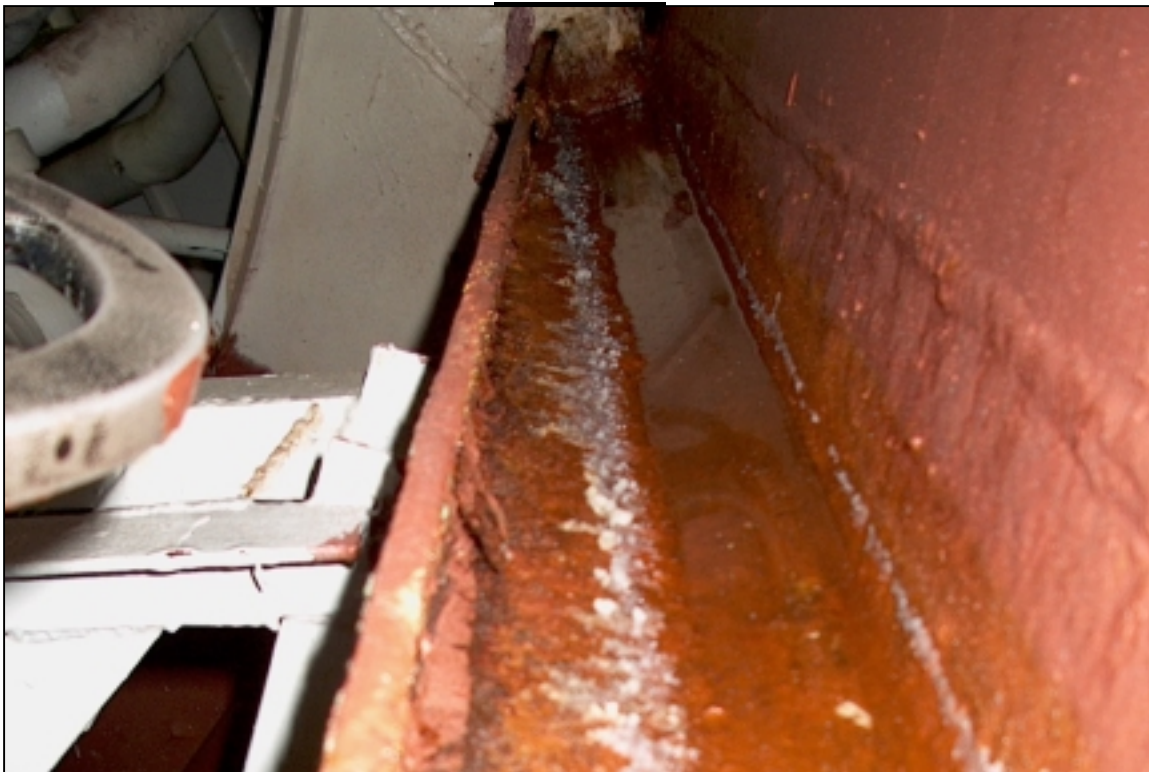
CORROSION CAUSED BY TRAPPED WATER UNDER THE HPAC.

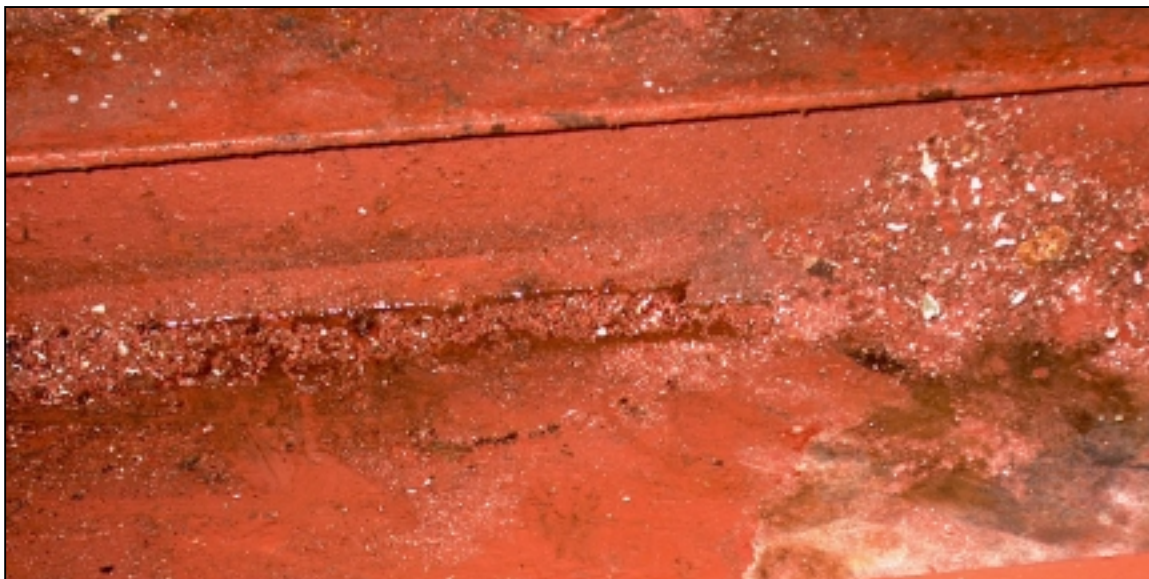
STRINGER (7), LOOKING INBOARD NEAR BOTTOM OF ESCAPE TRUNK

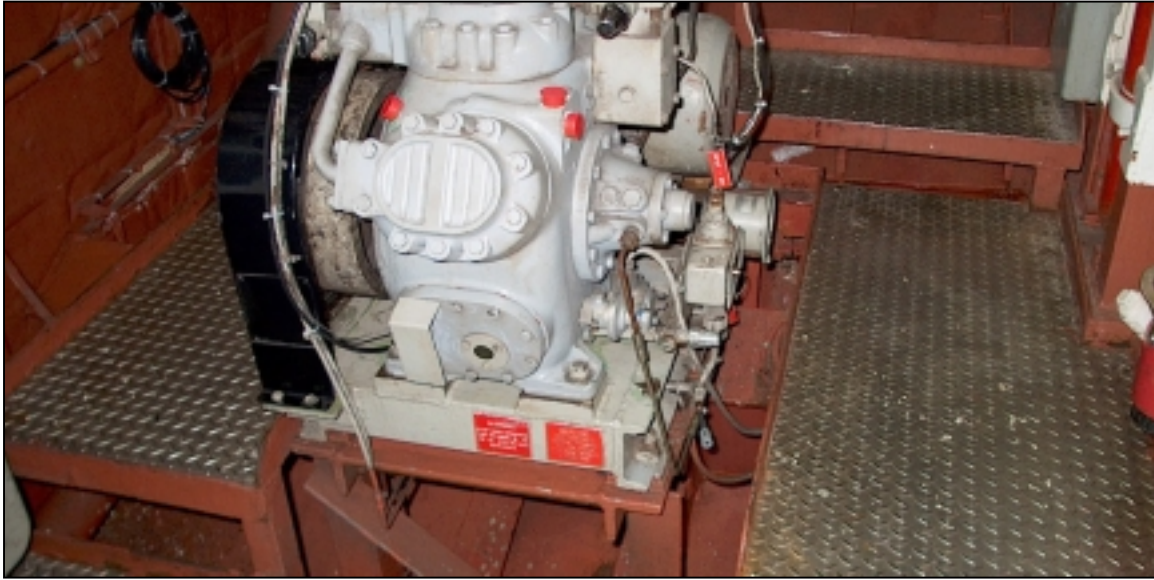
| AREAS OF CORROSION WERE FOUND UNDER REEFER COMPRESSOR NO. 2, UNDER HALON BOTTLE STATION AND INBOARD OF BALLAST BLOCKS AFT OF WF (196). MINOR CORROSION WAS FOUND ON SHELL PLATE WHERE IT MEETS WF (214) | | | | | | | | | |

REEFER COMPRESSOR NO.2. CORROSION WAS FOUND WHERE FOUNDATION MEETS SHELL PLATE.

| <b>RECOMMENDED REPAIRS: DUE TO NUMEROUS INTERFERENCES, (BALLAST BLOCKS, PIPING, ETC) RECOMMEND REPAIR ACTIVITY REMOVE BALLAST BLOCKS AND OTHER INTERFERENCES. CLEAN APPROXIMATELY 200 SF OF AREA TO BARE METAL, PRESERVE AND PAINT REPLACE INTERFERENCES.</b> | | | | | | | | | |

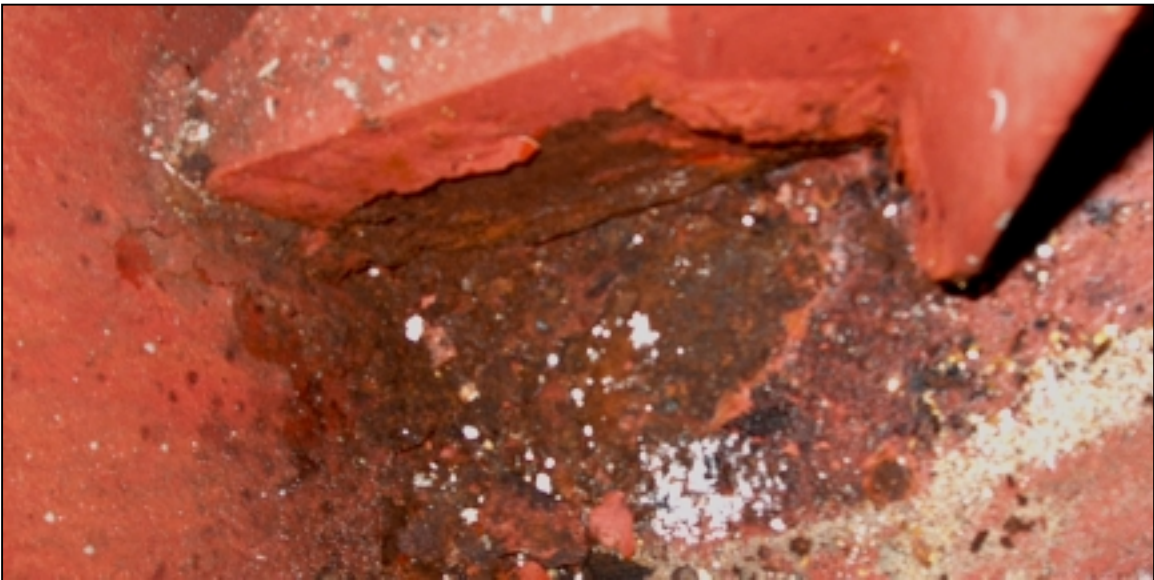
FOUNDATION FOR REEFER COMPRESSOR

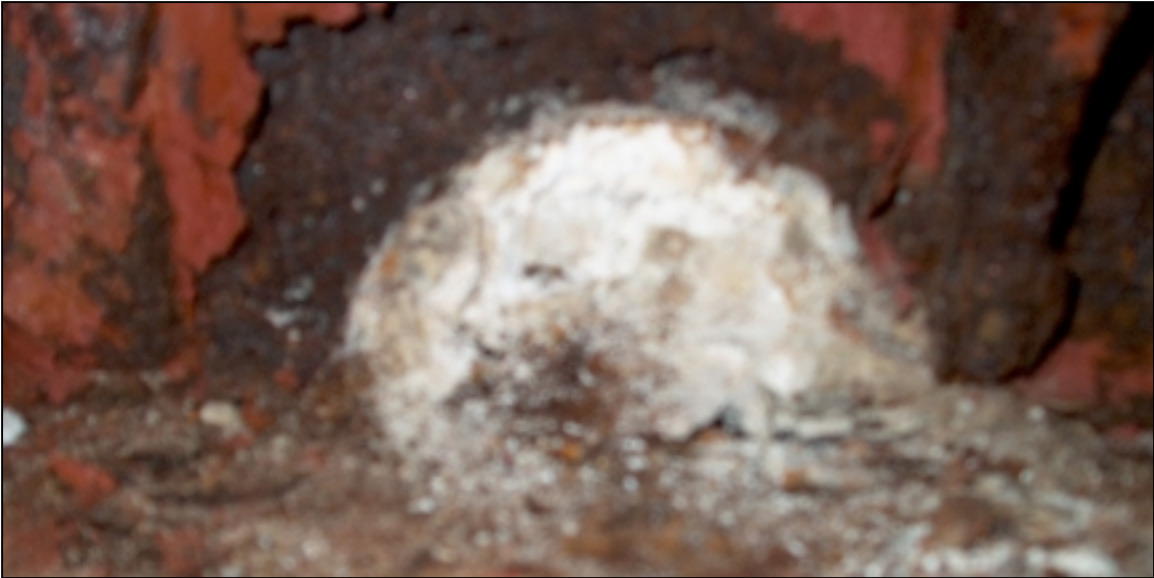
CORROSION INBOARD OF BALLAST BLOCKS AFT OF WF (196).

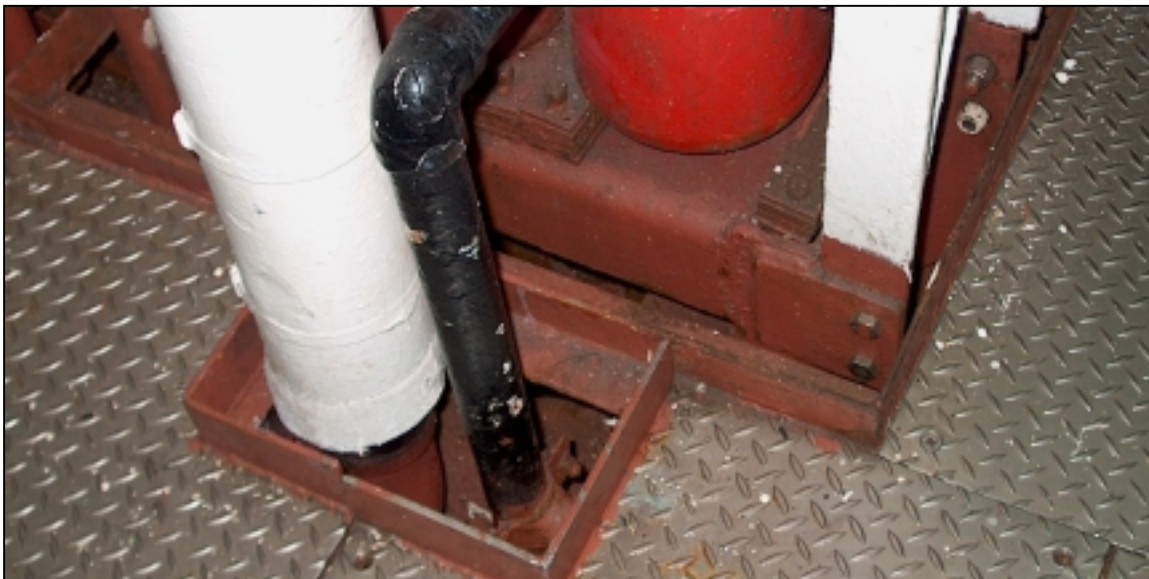
HALON BOTTLE STATION, PORT SIDE UNDER LADDER. NUMEROUS INTERFERENCES  
BELOW DECK GRATING PREVENT SHIPS FORCE FROM ADEQUATELY STEMMING  
CORROSION.

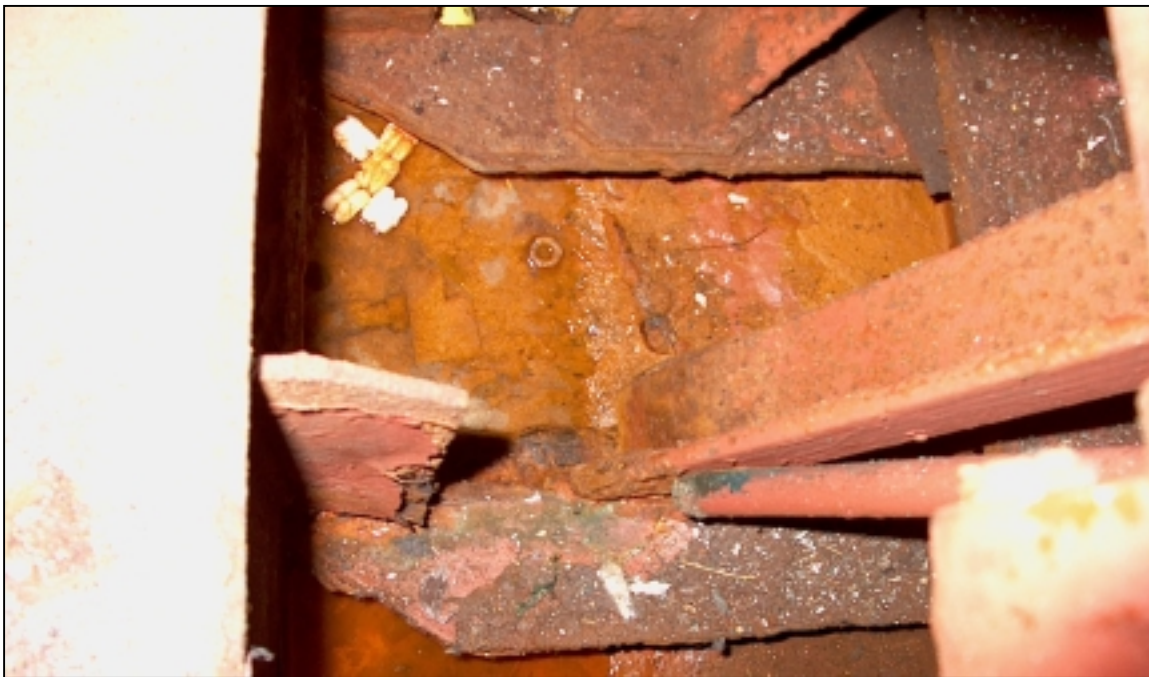
CORROSION ON SHELL UNDER HALON BOTTLES

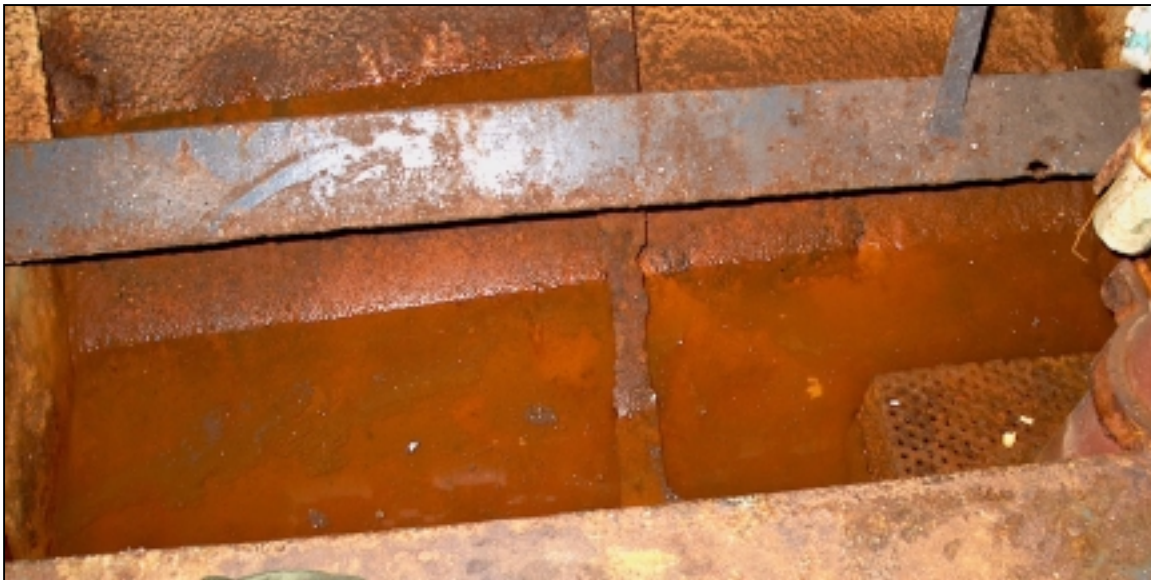
| FLANGE ON STRINGER (1) AT BHD (56) IS CORRODED. VERTICAL STIFFNERS FROM KEEL TO FIRST STRINGER ARE SEVERELY DETERIORATED. APPROXIMATELY 8 LF OF VERTICAL STIFFNER. ENTIRE BILGE AREA PORT AND STBD HAS LIGHT CORROSION. | | | | | | | | |

STBD BILGE POCKET, CORRODED VERTICAL STIFFNERS, HOLE IN STRINGER FLANGE.

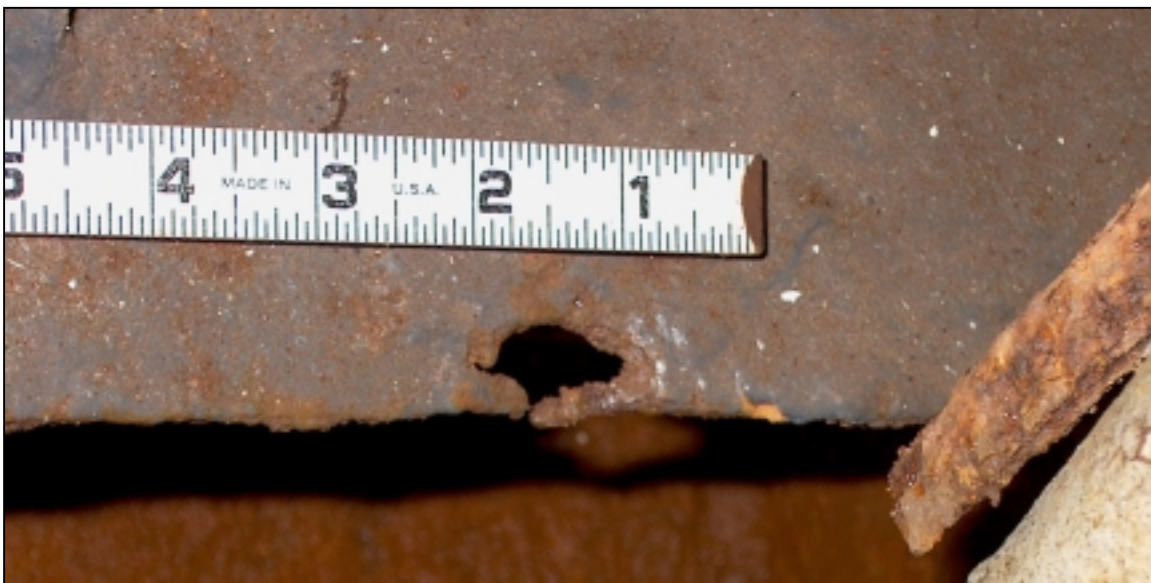
HOLE IN FLANGE OF STRINGER (1) AT BHD (56)  
SEE DRAWING FOR U/T READINGS

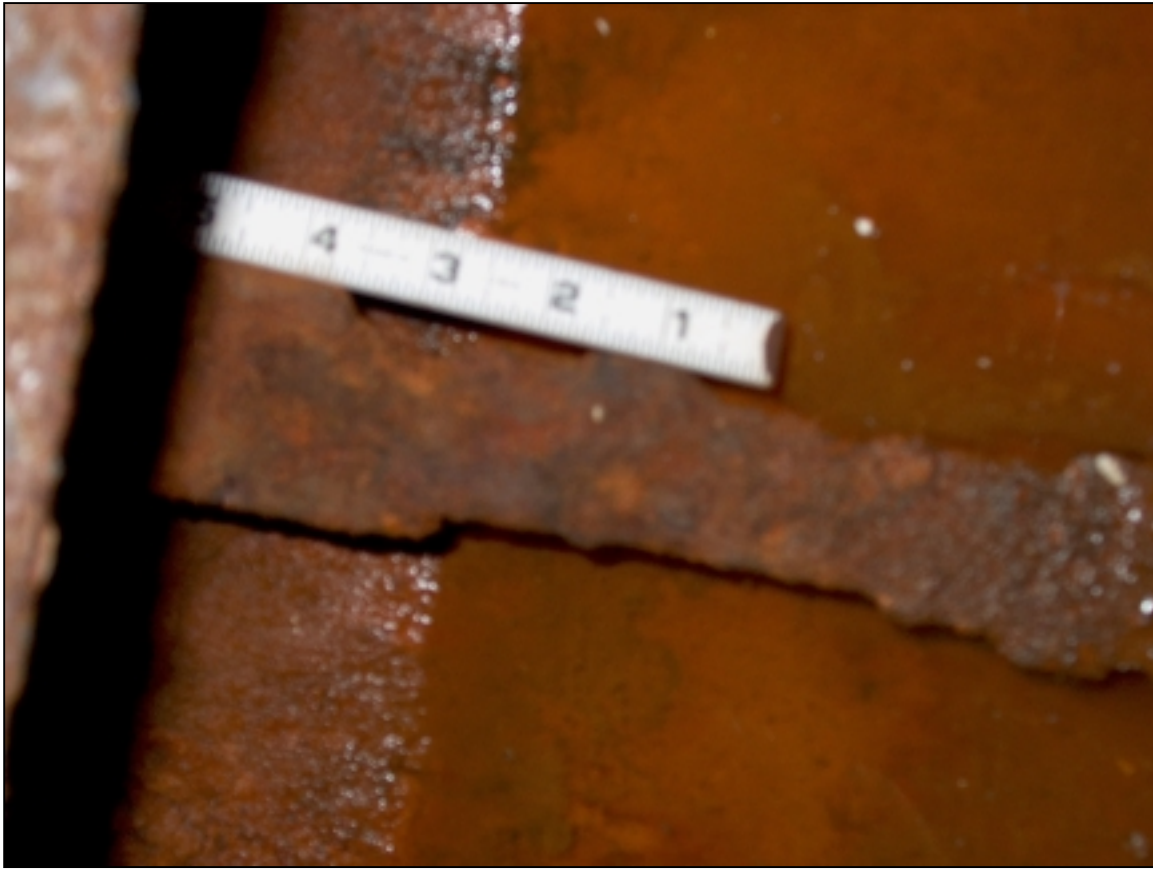
CORRODED (2 X 3) VERTICAL STIFFNER.

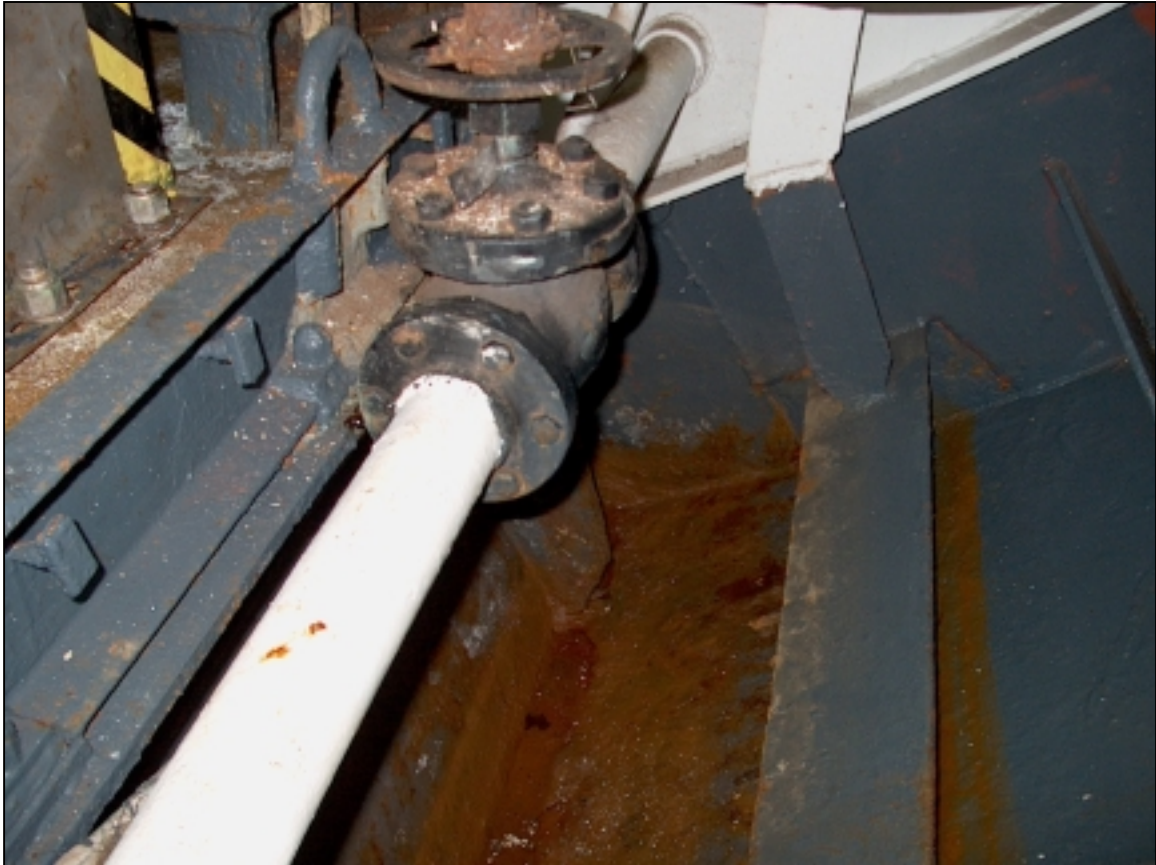
| LOCATION | AREA | RESULTS |
|---|--|---|
| 4-172-1-E FIRE PUMP ROOM | BILGE POCKET AREA, BHD (172-180) | APPROX 35 SF OF SURFACE RUST AND PAINT SEPARATION. |

BILGE POCKET AT BHD (172), U/T READINGS WERE SATISFACTORY  
SEE DRAWING

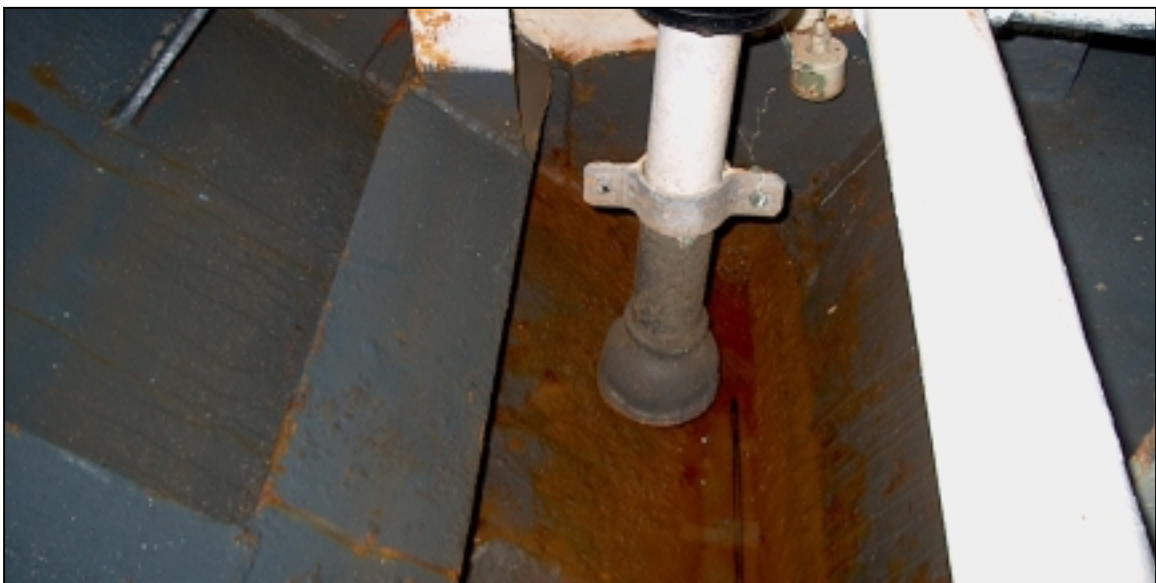
BILGE POCKET AT BHD (180)

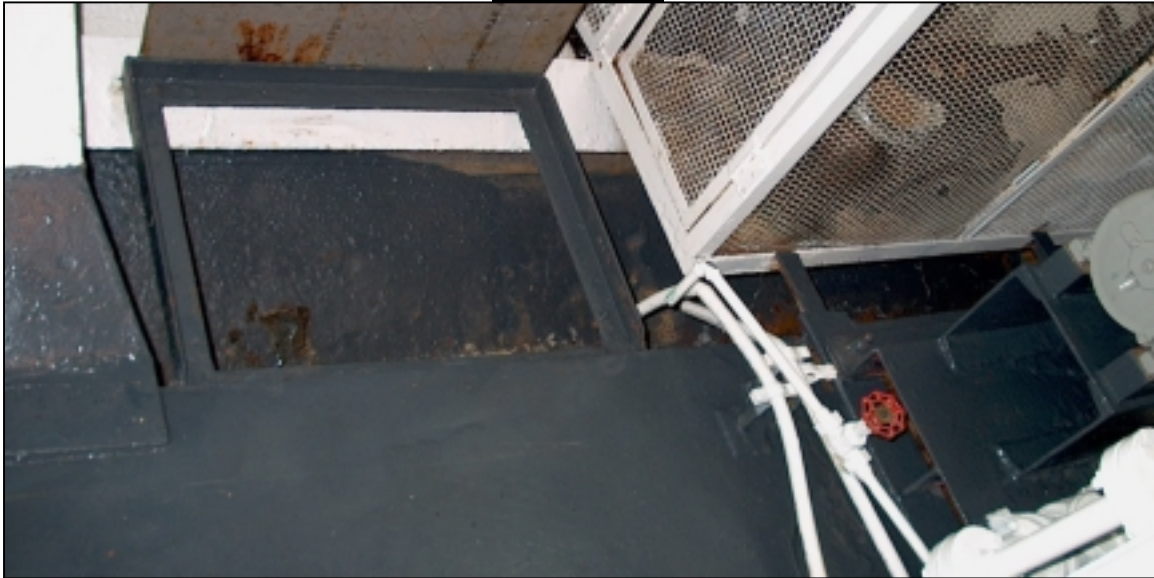
| LOCATION | AREA | RESULTS |
|---|--|---|
| 4-160-0-Q CHT ROOM | PORT SIDE, BILGE POCKET AREA FROM BHD (164-180) | APPROX 45 SF OF SURFACE RUST AND PAINT SEPARATION. |

PORT SIDE BILGE POCKET, FWD OF WF (172). U/T READINGS IN THIS AREA WERE SATISFACTORY. SEE DRAWING.

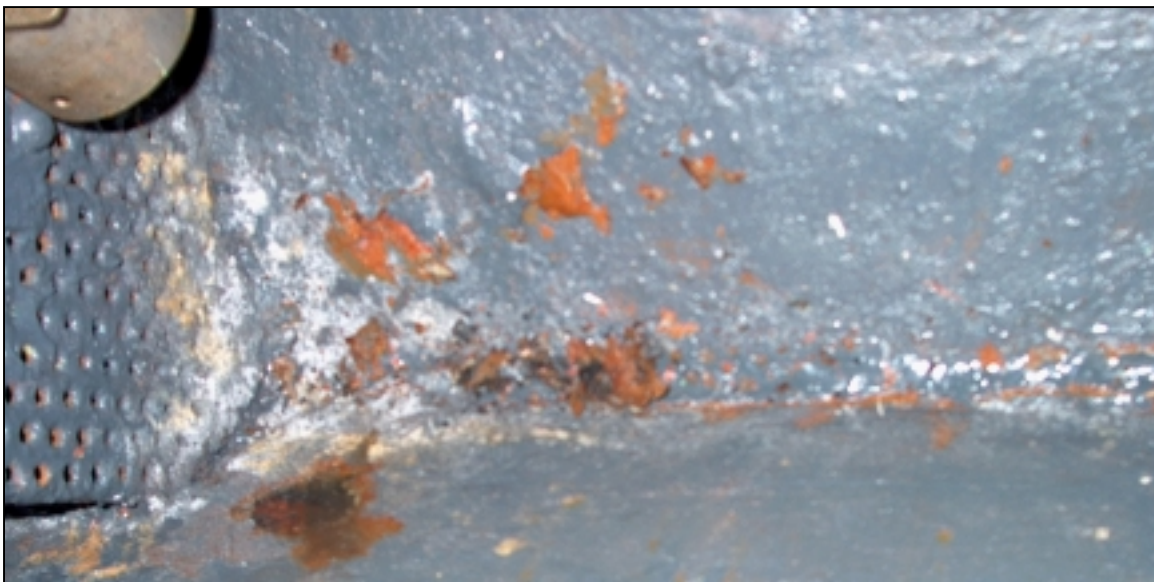
PORT SIDE EDUCTOR AT BHD (180).

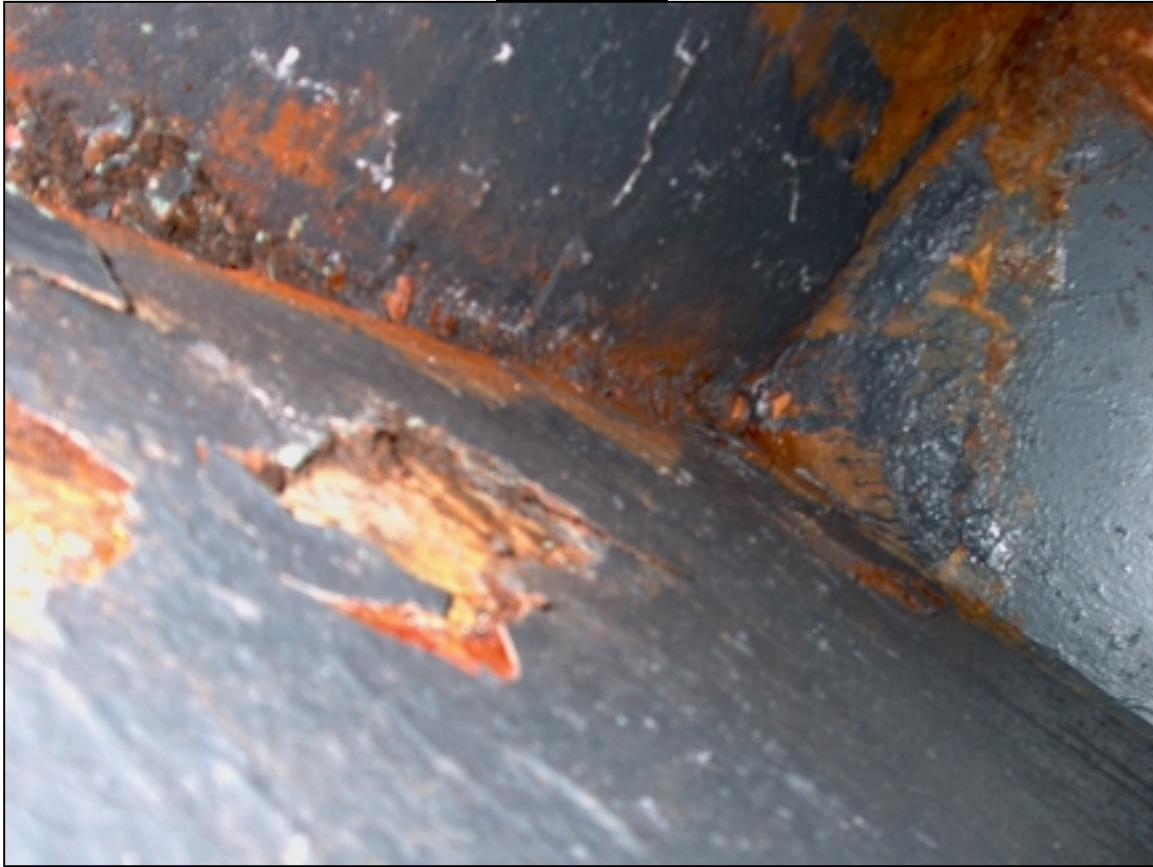
PORT SIDE BILGE POCKET AT BHD (164) POOR BONDING AND MOISTURE CAUSE  
PAINT SEPARATION, U/T READINGS WERE SATISFACTORY.
